**NASA TM X-3147**

**TESTS OF PROTECTIVE CLOTHING FOR  
THE SAFE HANDLING OF PRESSURIZED LAMPS**

*John G. Ewashinka*  
*Lewis Research Center*  
*Cleveland, Ohio 44135*

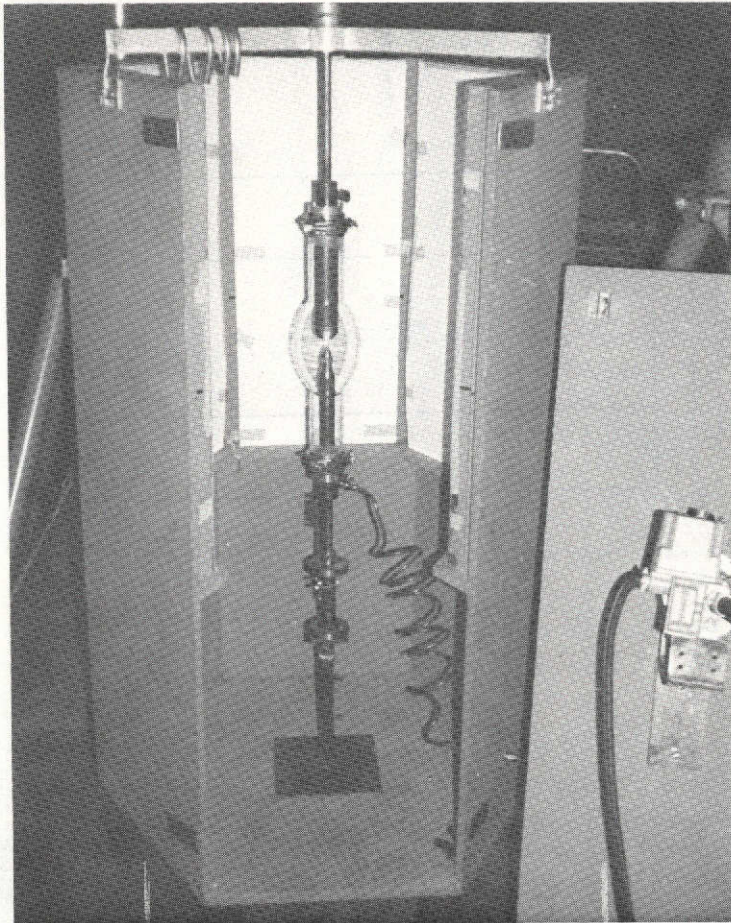
Figure 3. - A 20-kilowatt lamp mounted in test fixture.

A nonoperative pressurized lamp was suspended firmly in the center of the facility and exploded by a 1.6-centimeter- (5/8-in. -) diameter rod actuated pneumatically and driven at right angles to the lamp anode and cathode. Figure 3 shows a 20-kilowatt lamp mounted in the test fixture with one of the test panels removed. High-speed motion pictures (8000 frames/sec) were taken of the exploding lamp and the lamp fragments striking the clothing panels. The size of the lamp fragments and the number of strikes can be determined from the film. Three cameras were used, each covering two panels. Figure 4 shows the test fixture, the pneumatic rod, and the location of the three high-speed cameras.

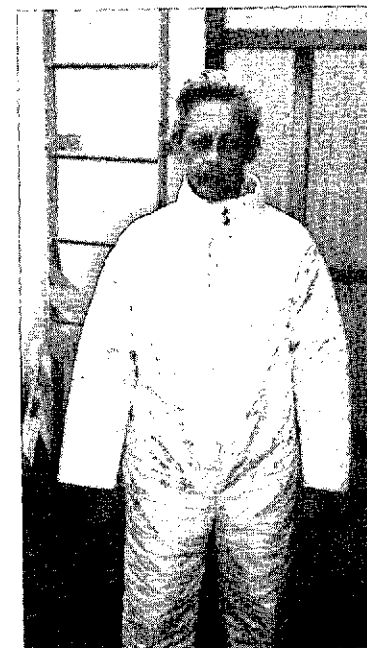
Figure 7. - New protective clothing (5024 nylon/ballistic felt/5024 nylon combination).

Chromed leather was not penetrated in its one test with a 6.5-kilowatt lamp. However, this material is heavy and stiff and is very cumbersome to personnel. Clothing of this material in use at Lewis weighs 4.5 kilograms (10 lbm) compared with a weight of 1.4 kilograms (3 lbm) for the equivalent in 5024 nylon/ballistic felt/5024 nylon clothing combination. Also, clothing constructed of the 5024/felt/5024 combination can completely cover vulnerable areas such as the neck, wrists, legs, and ankles and thus afford better protection than chromed-leather clothing. Figure 7 shows the 5024/felt/5024 clothing combination made into a protective suit covering all these vulnerable areas.
